A488 Hanwood

**Speed Reduction /
Pedestrian Safety measures**

Feasibility Report

Report Reference: 1071414

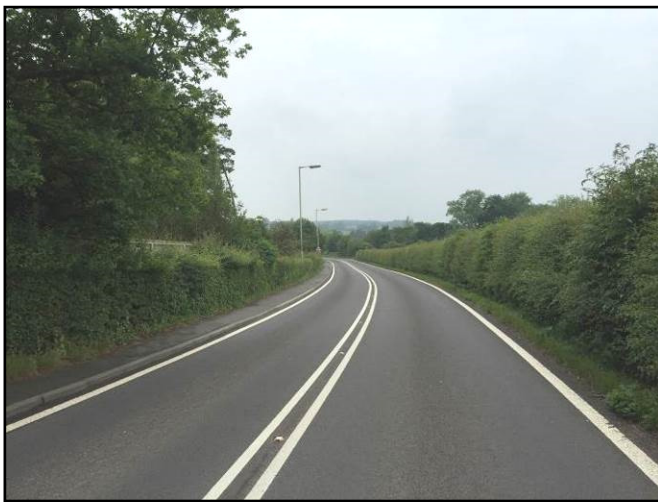
Photo 1 – view south along non-built up link between eastern end and Great Hanwood.

- 2.9 Road markings consist of double-white line systems through Hanwood Bank (mentioned earlier) and at the southern extremity of the village. Centre warning lines are present throughout the remainder of the village. It is unusual to provide double-white lines within an urban area, indeed Chapter 5 of the Traffic Signs Regulations and General Directions (TSRGD) 2016 states “double lines should not normally be used in built-up areas, as preventing vehicles from stopping could be unduly restrictive”. However it is understood that the markings have been provided following local pressure despite the non-standard nature of them to prevent overtaking movements and therefore higher speeds through the undeveloped section of Hanwood.

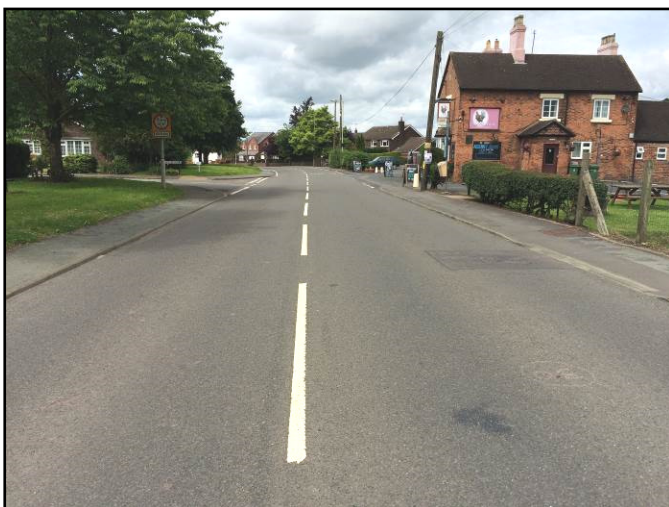
Photo 2 – A488 Hanwood looking west in vicinity of The Cock Inn P.H.

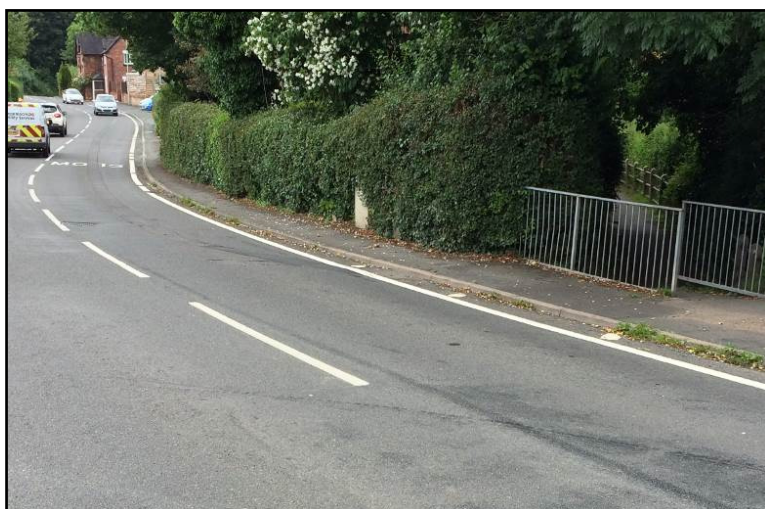
Photo 3 – A488 Hanwood narrow footway alongside carriageway and alternative footpath access to rear of School / Village Hall (right of photo).

4.5 Due to concerns related to the narrow footway at the south-west extremity of the village, a peak hour pedestrian survey was undertaken at Hanwood Bridge to observe the most popular route for pedestrians to take when walking to/from the Primary School. There are two possible routes for pedestrians walking to/from the school from this point: the narrow roadside footway adjacent to the A488, or an off-road footpath which leads to the rear of the School.

4.6 The survey was undertaken on Thursday 21st July in the AM peak (08:15 to 09:15) and PM peak (14:30 to 15:45). The combined AM and PM peak hour results show 81 pedestrians were observed, of which 70 (87%) chose the rear footpath (off-road) route to the school and 11 (13%) walked on the footway alongside the carriageway under the railway bridge. Road safety education with the school where the use of the safer off-road footpath route to school is further promoted could be considered.

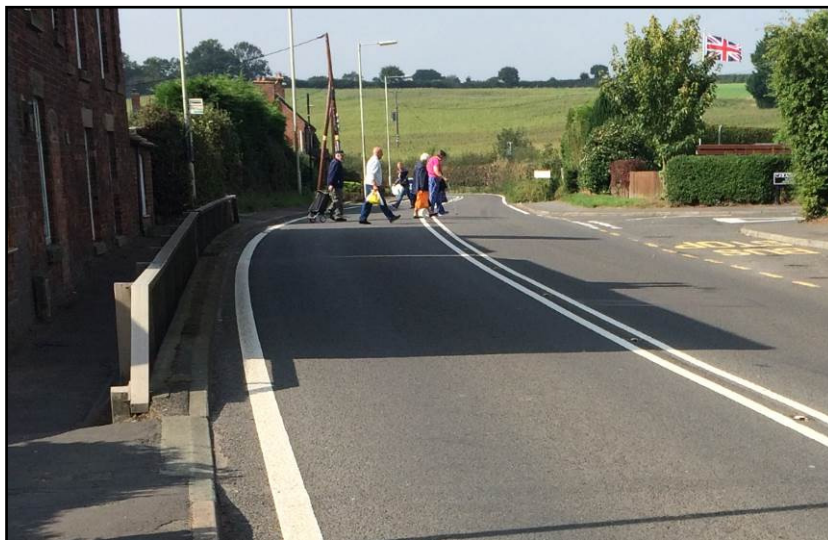
- 5.2 Currently there is only one formal pedestrian crossing point in the village (Puffin Crossing) near Hanwood bridge described earlier in report, paragraph 2.8. However there are other locations observed in the village where people cross the A488, i.e. where the bus stop alights opposite the Caradoc View housing estate. This can lead to pedestrians crossing at the same time when gaps in the traffic are available, as observed below.

Photo 4 – Hanwood bank crossing movements near Caradoc View.

As discussed in paragraph 5.2 there is a pedestrian desire line near Caradoc View generated by the bus stop. It is understood that there is an outline planning application for a housing development on land to the west of Caradoc View. This includes the provision of a pedestrian refuge in order to address this desire line and that created by the proposed development to the footway on the opposite side of the road. Some localised carriageway widening into the development site will be required here to facilitate the refuge.

A pedestrian refuge would assist pedestrians by allowing pedestrians to cross the road in two stages. The refuge would appear to be more appropriate than other forms of crossings i.e. a Zebra or Puffin Crossing which cater for locations with high pedestrian demand and if implemented in locations with relatively infrequent movements begin to be ignored by drivers.

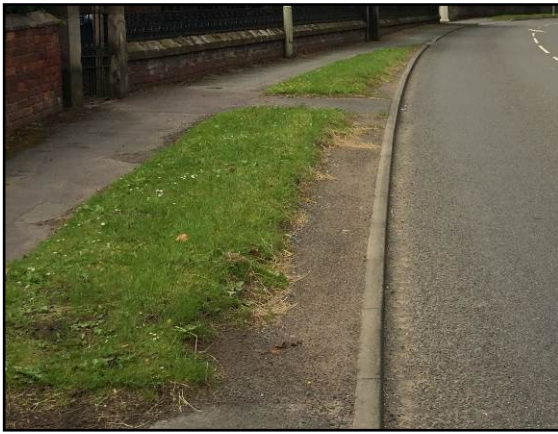
- 5.3 During the site visits no on-street parking was noted anywhere throughout the village. On-street parking can be a useful aid in providing a mobile calming effect and the absence of this is enabling traffic to travel through the village without obstruction or the need to reduce their speed. A reappraisal of the existing sections of double-white line systems would be required in order to facilitate on-street parking.
- 5.4 One area where parking does appear to occur (although not observed) is alongside the village church. There is significant verge deterioration for a short length along the south side of the A488 presumed to be caused by occasional church related parking.

Photo 5 – A488 Hanwood o/s Church showing verge deterioration.

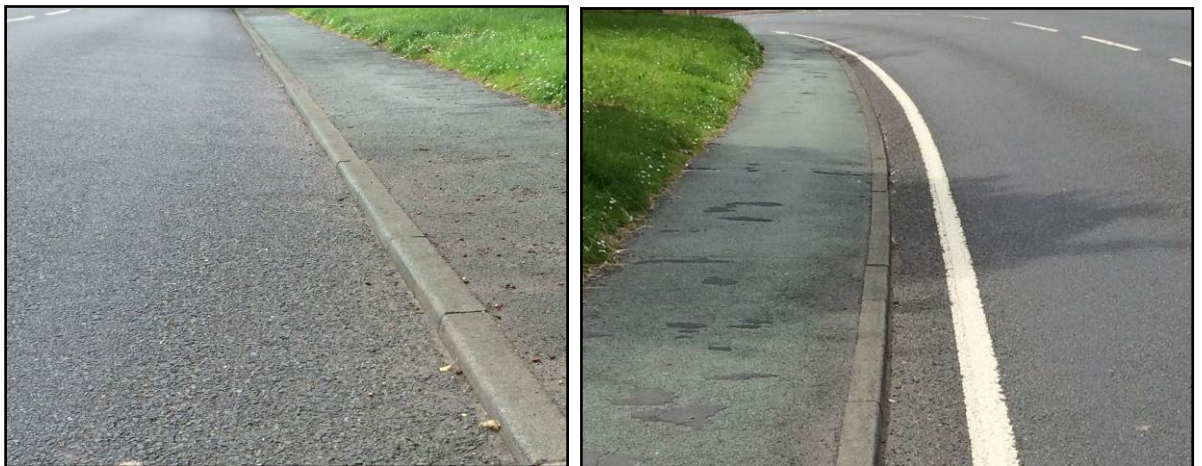
- 5.5 There are several locations throughout the village where the kerb upstand between the footway and carriageway is low (approx. 20 – 50mm) probably due to the regular overlaying of the carriageway surface (without planing). The low kerb upstand combined with narrow footway and in some instances narrow carriageway alongside provides pedestrians with little protection from passing traffic. The low kerb presents an increased risk of vehicle overrunning which may be one of the reasons why there are reports of people feeling vulnerable when walking within parts of the village.

Photo's 6 and 7 – A488 Hanwood showing examples of low kerb upstand.

The most effective method of removing road markings is to resurface or surface dress the carriageway. In addition it would be desirable to address the issue regarding the low kerb heights through the village. Therefore, the ideal scenario would be to plane out the carriageway to a suitable depth to restore the kerb height to the correct level before resurfacing the carriageway. A cheaper option would be to renew the existing surface-dressing, which appears to be in the region of five-years old (without planing).

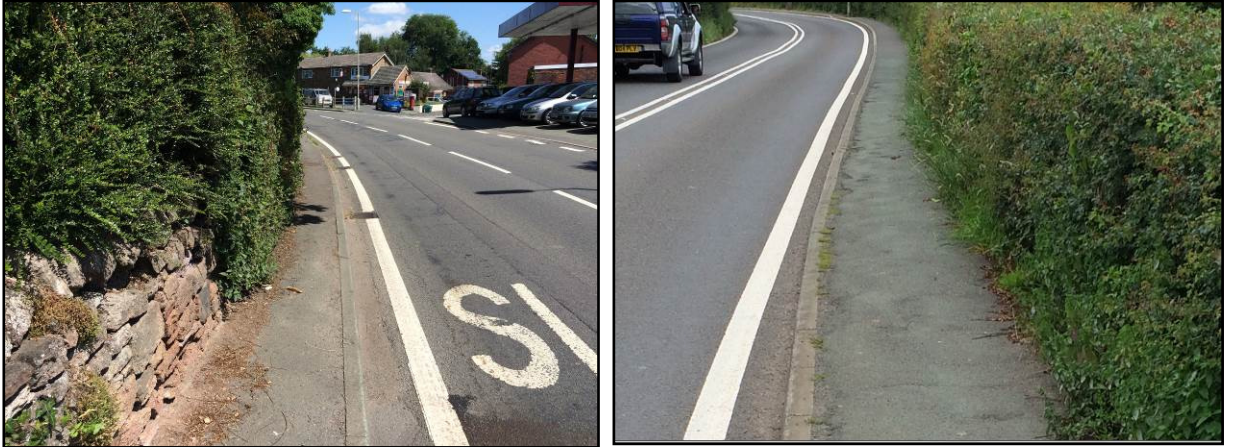
- 5.6 There is notable overgrown vegetation alongside the footway in some key places which appears to encroach into the highway. This is reducing the available width for pedestrians along sections of footway which are already considered to be narrow, increasing the feeling of vulnerability to passing traffic. In some instances this may force pedestrians or those walking with pushchairs or mobility aids into the carriageway.

Photo's 8 and 9 – A488 Hanwood showing examples of narrow footway/overgrown vegetation.

The identified areas of overgrown vegetation should be cut back to ensure footways are kept as clear as possible. Whilst this is responsibility of the adjacent land owner, the Council has the ability to carry out this work and re-charge the respective land owners.

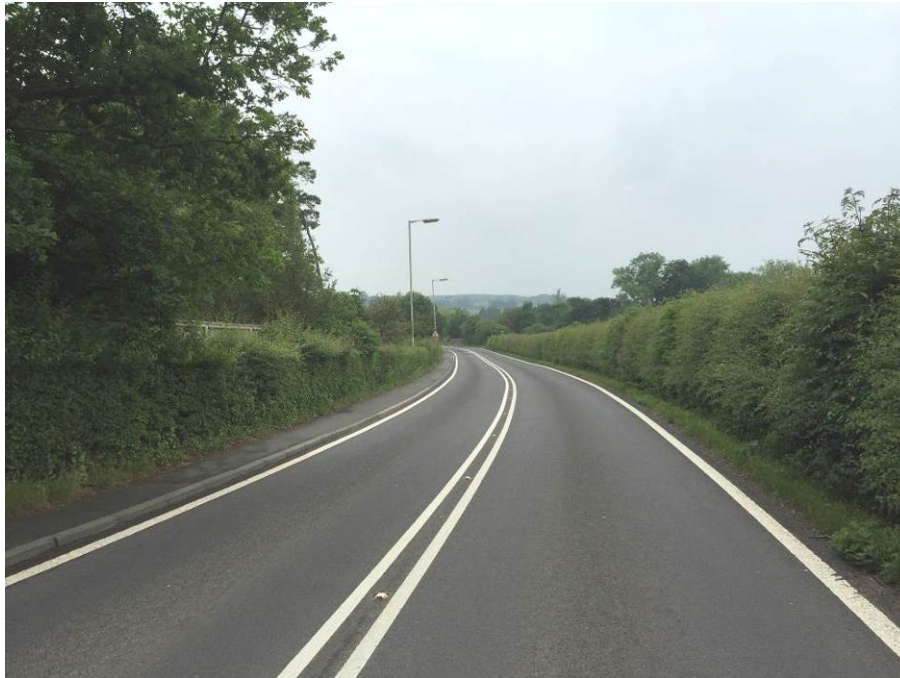
Photo 10 – A488 Hanwood Bank existing double white line system

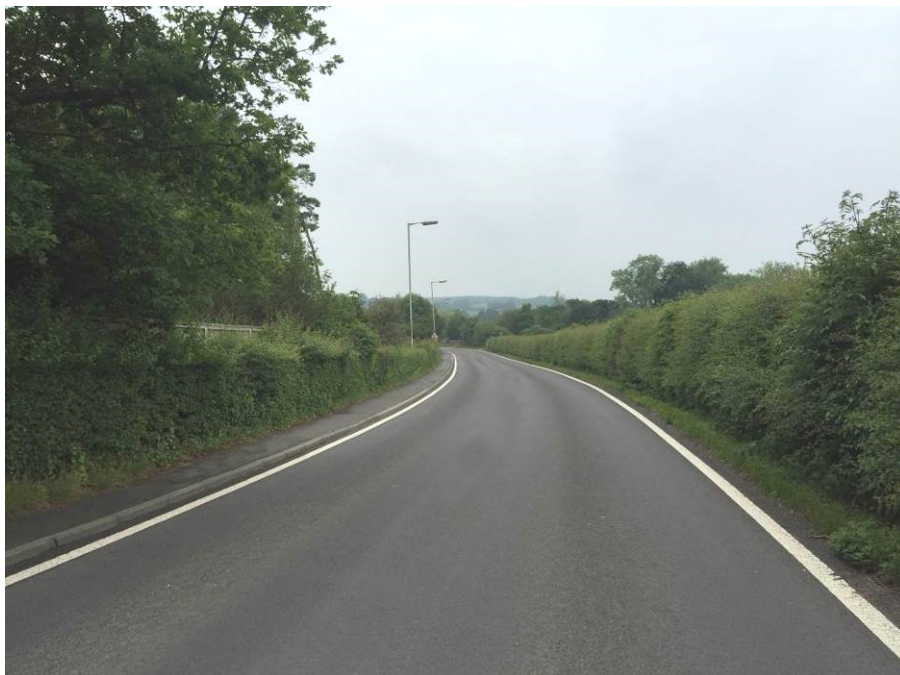
Photo 11 – A488 Hanwood Bank showing photo impression of lining removal (option 6.2).

Removing these road markings can make the road and its surroundings appear narrower to the driver, which can create a slower speed environment. In recent schemes in Shropshire the removal of centre lines has been shown to have an immediate effect with reductions of between 3-4 mph or more, sufficient to reduce the severity and number of accidents and to improve confidence and mobility for pedestrians.

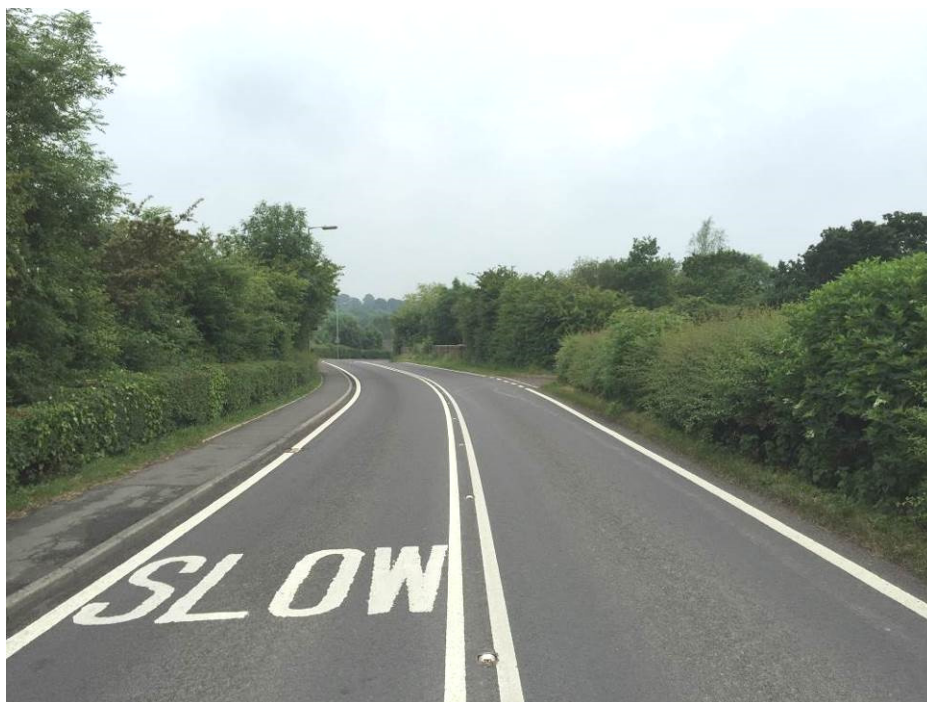
Photo 12 – A488 Hanwood Bank double white line system

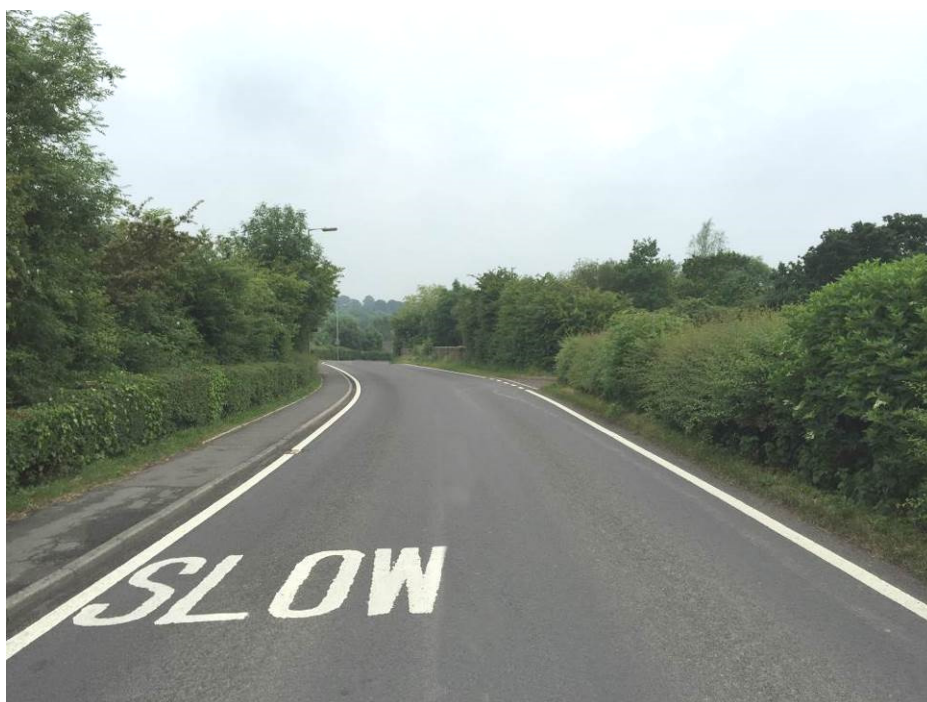
Photo 13 – A488 Hanwood Bank showing photo impression of lining removal (Option 6.2).

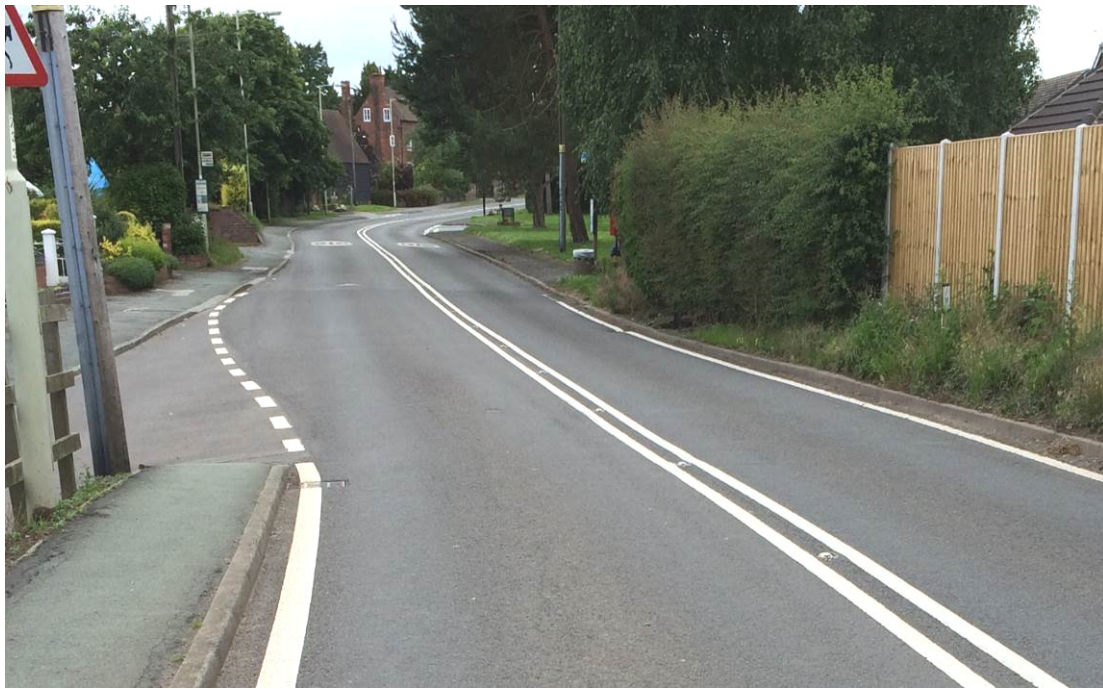
Photo 14 – A488 Hanwood near Post Office Lane showing existing layout.

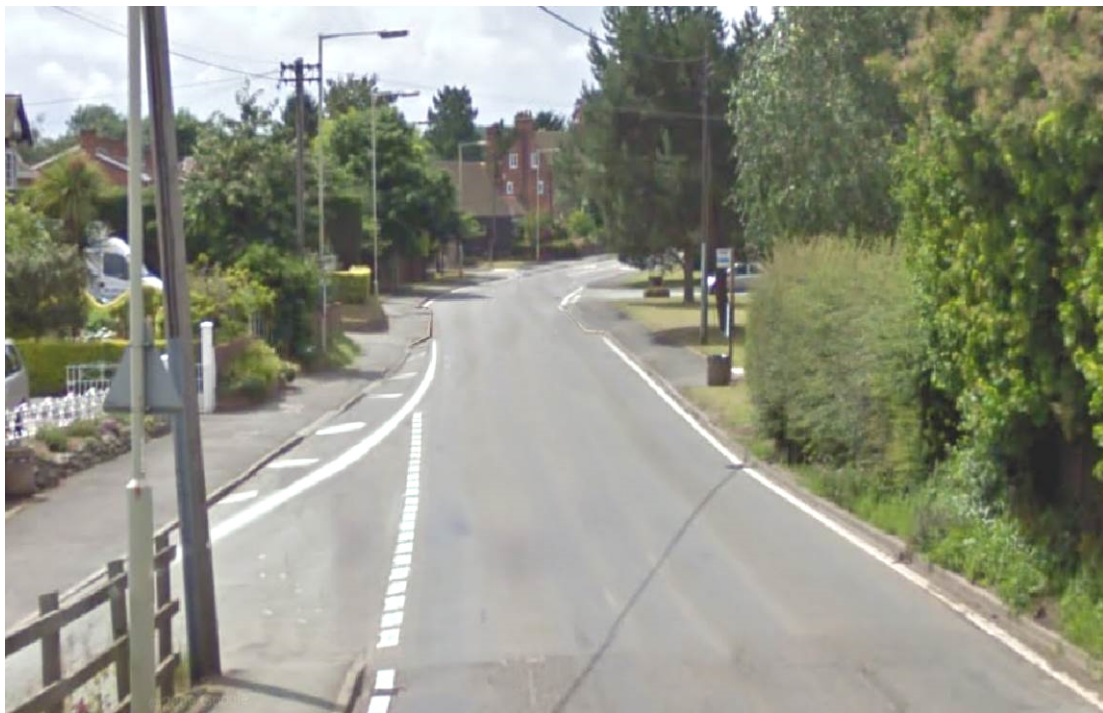
Photo 15 – A488 Hanwood near Post Office Lane showing photo impression of road narrowing and lining removal (Option 6.4).

Reducing the carriageway width from 7.3 metres to 6.0 metres via small build-outs over a short length would create a narrowing effect and help to serve as a reminder to drivers that they are travelling in an urban area. This would be particularly effective when coupled with the removal of the centre line marking.

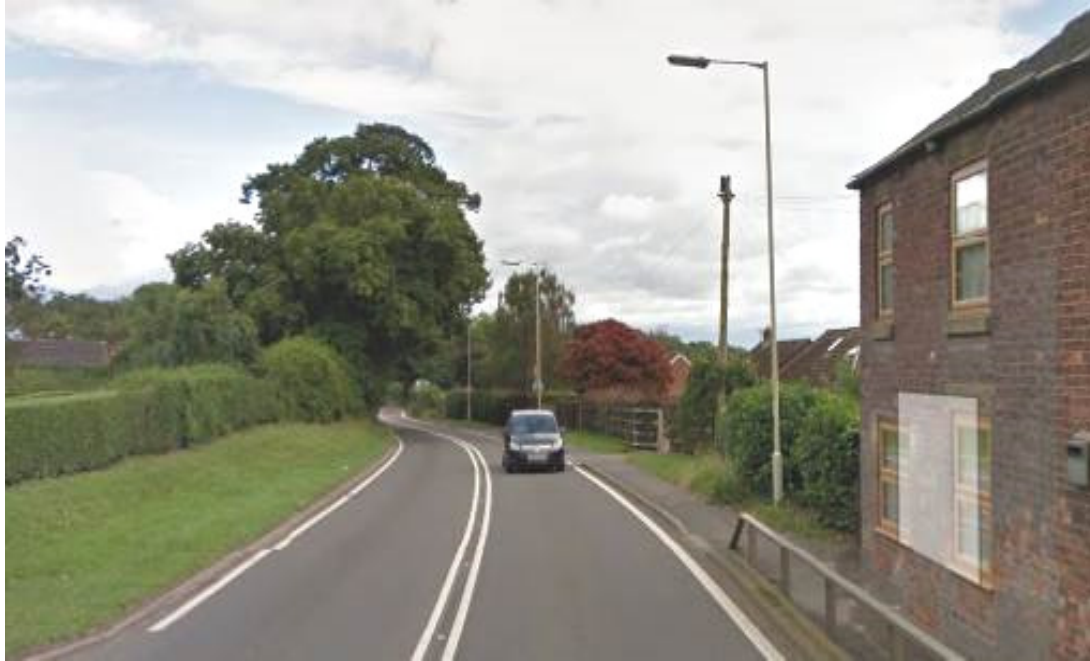
Photo 16 – A488 Hanwood east of Caradoc View showing existing layout view looking eastbound.

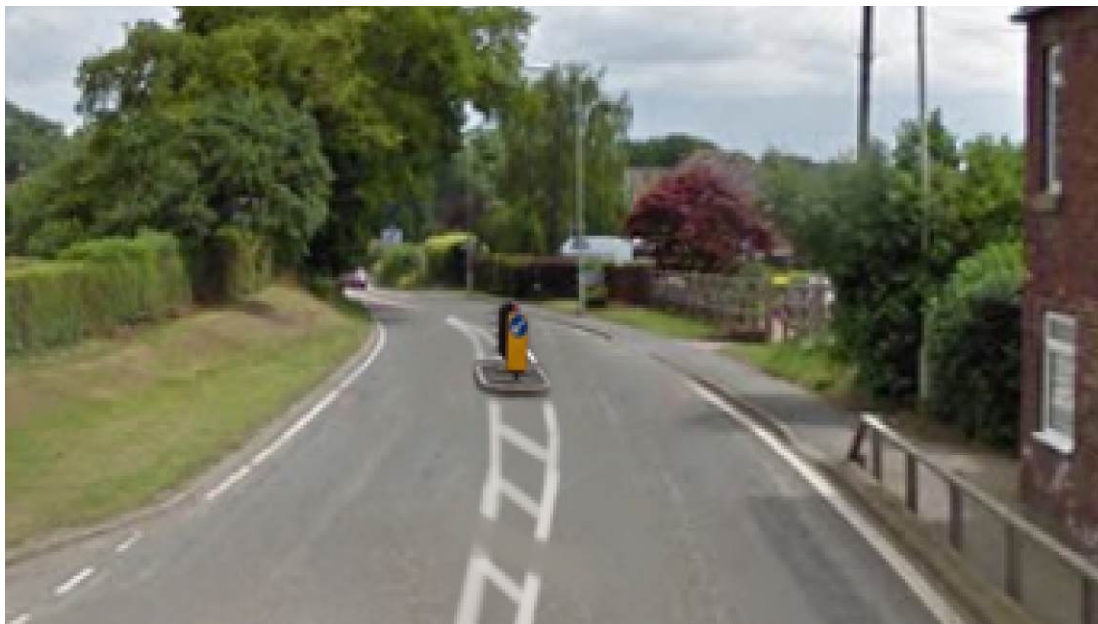
Photo 17 – A488 Hanwood east of Caradoc View showing photo impression of traffic island as a gateway feature (Option 6.3). Photo shows eastbound view - gateway signs placed in the verge would accompany the island, facing westbound traffic.

Enhanced 30mph gateway points would be beneficial to alert drivers to the fact they are entering the village from each direction. It is feasible to install traffic islands in the centre of the carriageway, which will physically narrow the carriageway running lanes to approximately 3.0 metres wide at each entry point. The traffic islands would support rural village style gateway signs mounted either side of the carriageway which will provide a strong visual message to drivers.
